Title: Locomotive Inbound Inspection Report
 Document Control No.: 10007 Revision: A
 Release Document : 08/29/2014 Revision Date: 08/29/2014
 Page: 1 of 4 Review Date: 04/03/2015

Model: C40-8 Road No.: NREX 9239 Frame No.: S.N. 45788 Sold To: _____
 OEM Serial #: _____ Date Built: 1988 Origin: _____
 Inspector: J. REININGER / J. McCLUSKY Location: MT. VERNON, IL

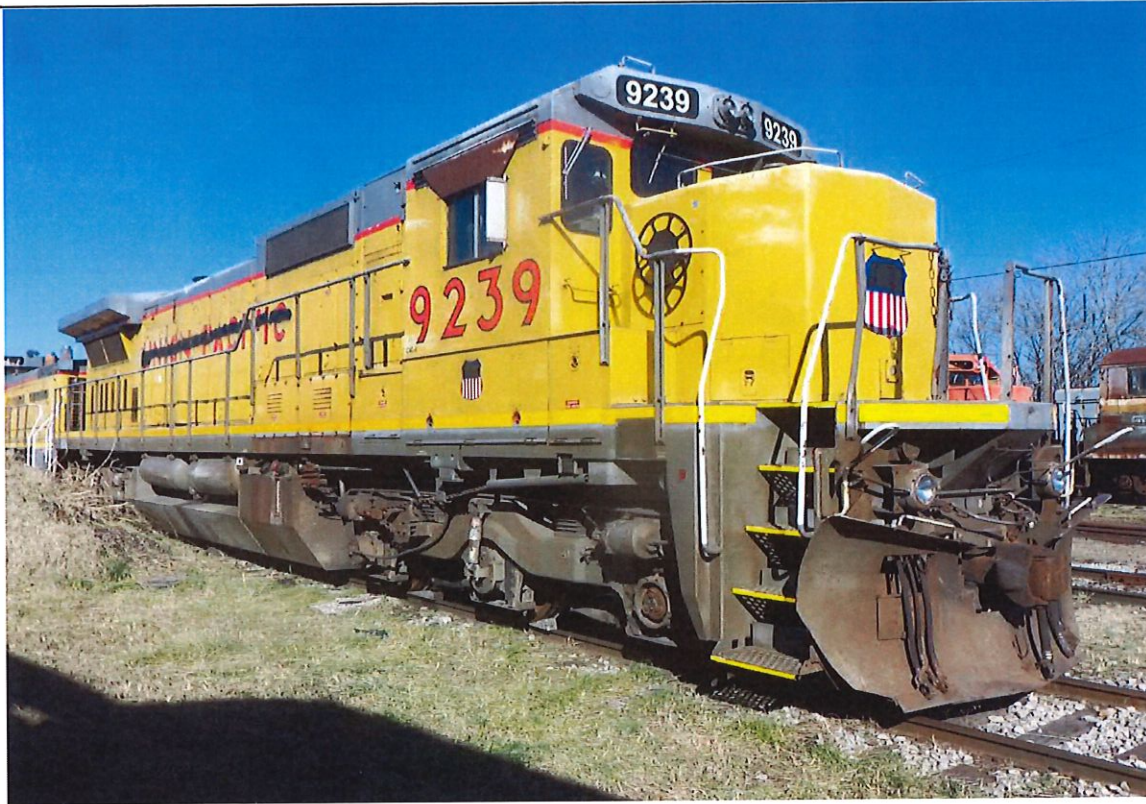
DENT IN FRONT SILL BELOW CROSSOVER DECK AREA
CORNERS OF TOP END SHEETS NEAREST CUT LEVER HANDLES BENT ALL BENT
MULTIPLE CARBODY DOORS MISALIGNED
FRONT AND REAR CROSSOVER POSTS BENT
RUST DAMAGE, FRONT OF CAB ABOVE WINDOW
ENGINE IS DAMAGED – CAM BROKEN OFF AT GEAR CAUSING HOLES/DAMAGE TO PACK AND
ENGINE, NEAR LEFT SIDE GENERATOR
HAS THREE CAB LIGHTS BUT ONE IS DAMAGED
HAS PREHEATER, AMOT, 7 GPM PARAGON FUEL PUMP
