Title: Locomotive Inbound Inspection Report

Document Control No.: QF-10007

Release Do	ocument :		
			MOVI	NG FO	RWA	RD	Revision: R	lev 1		
Model	3GS21B	Road No.	2009	Frame No.		Sold To				
OEM Serial #		Date Built	2007	Origin_						
Inspector:	BRIGGS			Location: 5	SILVIS			Date:	2/4/2016

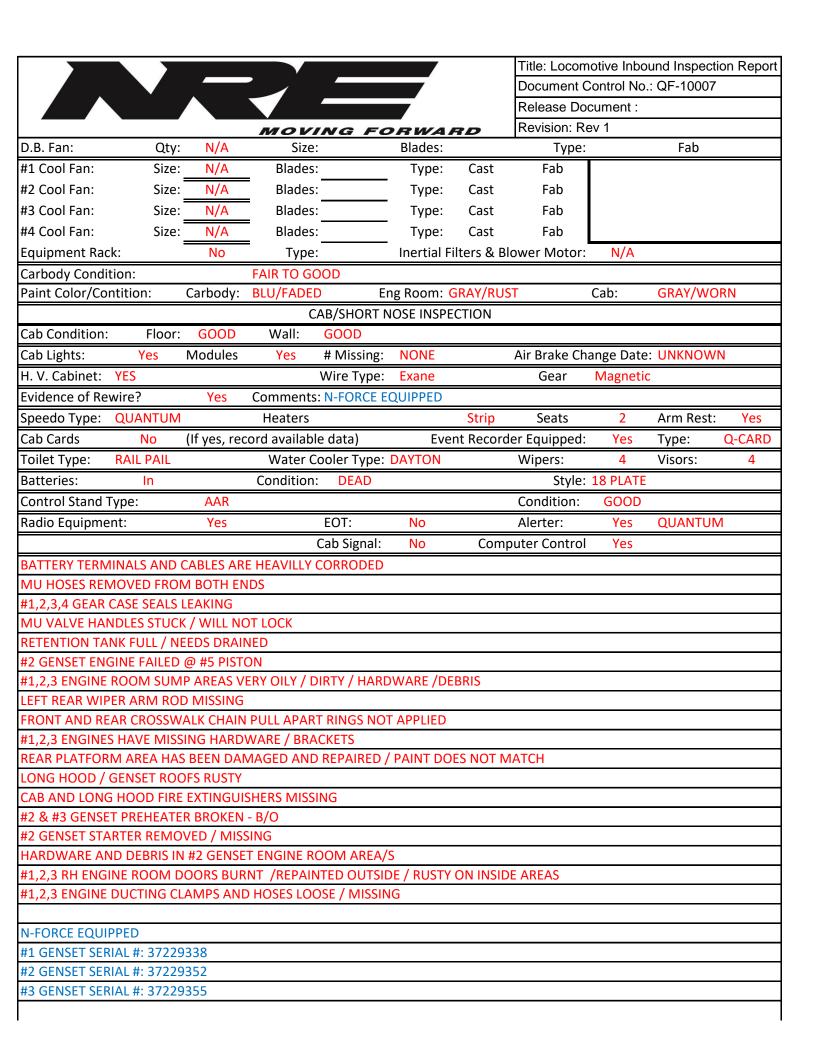
Release Document :
MOVING FORWARD	Revision: Rev 1
REAR CAB DOOR WALKWAY /TREADPLATE AREA RUSTED	
REAR CAB STEPS RUSTED OUT	
FRONT CENTER CAB WINDOWS LEAKING / RUSTY AT BOTTOM AREAS	
TOILET NEEDS SERVICED	
RIGHT CAB SLIDER WINDOW STOP MISSING	
CHOPPER COMPARTMENT VERY DUSTY / DIRTY	
BOTTOM FRONT CAB STEP PARTIALLY CUT OFF AT REAR EDGE	
RIGHT CAB AWNING RUSTED THRU AT TOP AND BOTTOM EDGES	
RIGHT CAB WALL RUSTED OUT AT AWNING SLIDER TRACK AREA	
REAR COUPLER ANTI CREEP NEEDS ADJUSTMENT	
RIGHT REAR COUPLER SUPPORT BOLT LOOSE	
/	
(attach additional pages if needed)
